Inspection Report

Commercial Report

1234 Elvis Presley Blvd
Rogers AR 72756

A Superior Inspection LLC

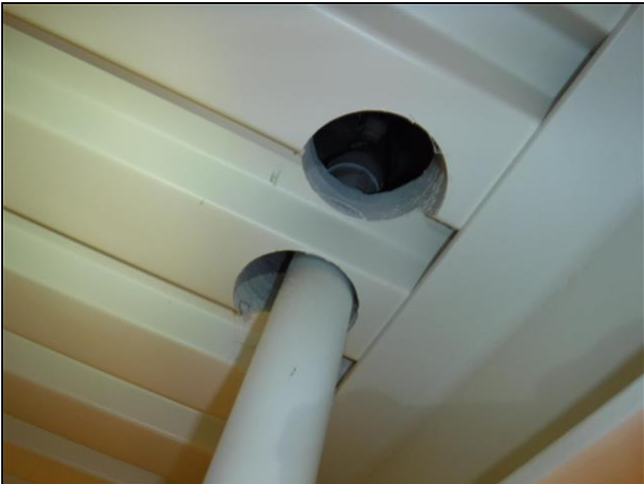
105/103 - The firewall separation between floors is missing in visible locations. This does not afford the intended protection against a fire in an adjacent unit. I recommend a qualified contractor to evaluate/ upgrade all floor penetrations (both hidden and exposed) for the required fire protection.

1.4 Item 1(Picture) 105 - Unsecured openings to the upstairs residential units.

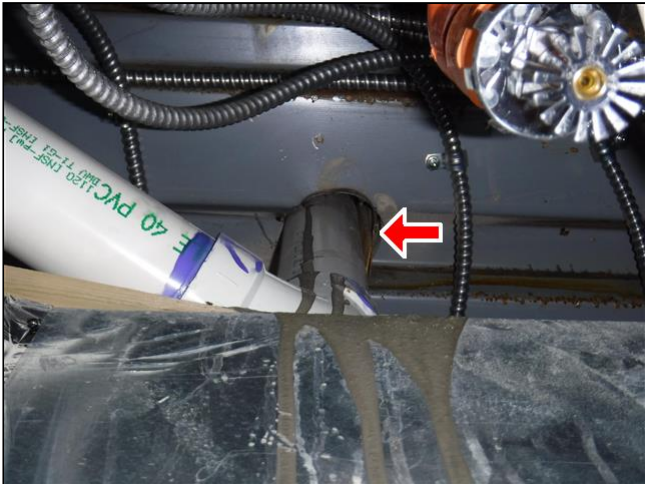
1.4 Item 2(Picture) 103 - Unsecured openings to the upstairs residential units.

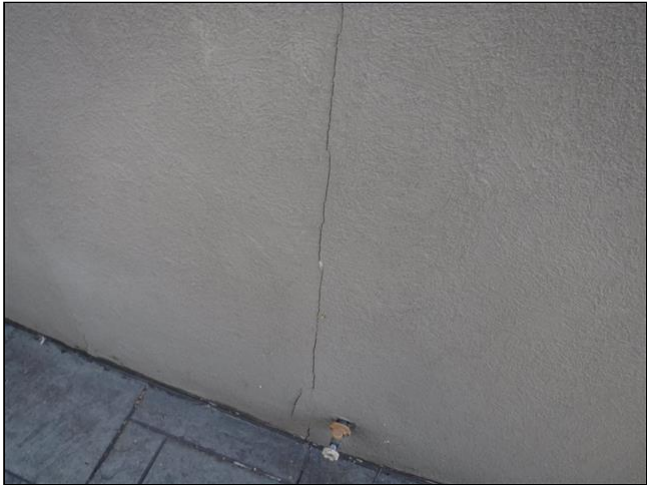
- (1) The building wall on at the rear of the property appears to be clad with a product known as Exterior Insulation Finish Systems, "EIFS," also referred to as "Synthetic Stucco." Many EIFS clad houses have revealed moisture related problems such as deteriorated wood framing and pest infestation.
- (2) The EIFS siding at the rear of building is beginning to deteriorate at the seams causing cracks and is damaged from the gate lock on the corner of the building. Further deterioration can occur if not addressed. Recommend a licensed EIFS/Stucco contractor to evaluate and repair as needed.

2.0 Item 1(Picture) 101 - Rear building EIFS is cracking at the seams.

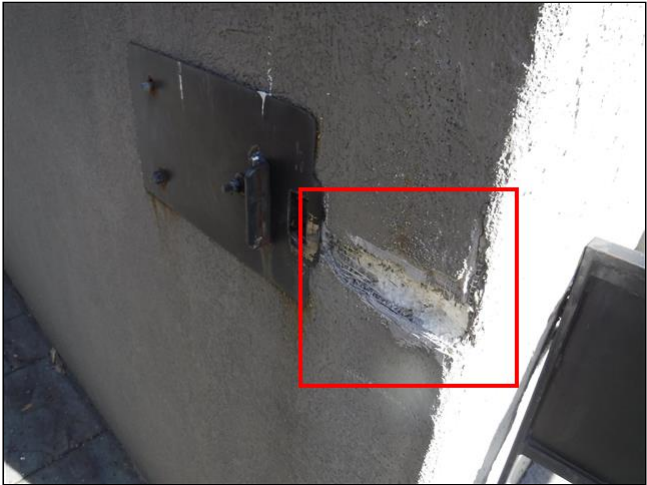
2.0 Item 2(Picture) 101- Exterior rear wall has been damaged by the gate lock.

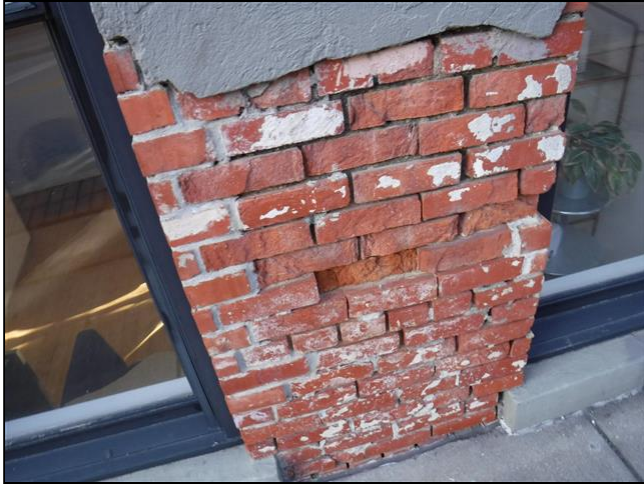
(3) The brick/concrete siding at the exterior shows advanced deterioration and is missing mortar in areas. Further deterioration can occur if not addressed. Recommend a licensed masonry contractor to evaluate and repair/replace as needed.

2.0 Item 3(Picture) Aged/Deteriorated bricks on the exterior of the building.

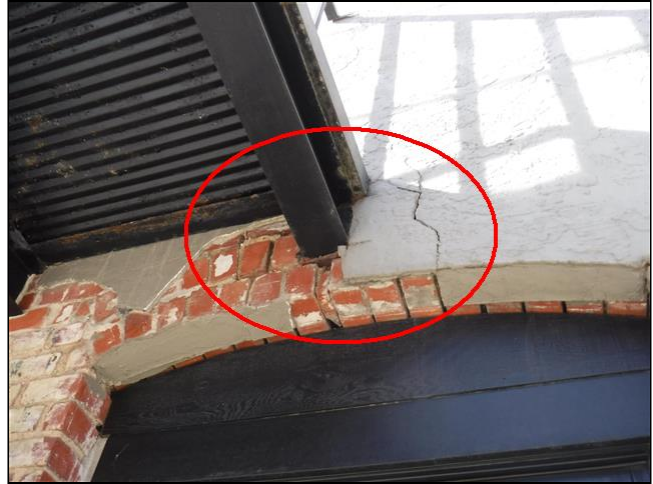
2.0 Item 4(Picture) Brick and concrete screed deterioration at the 2nd story patio on the front of the building.

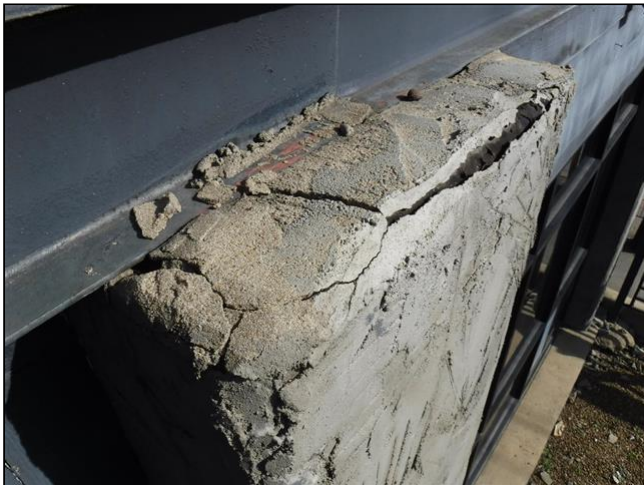
2.0 Item 5(Picture) 101 - Top concrete screeded pillars show advanced deterioration and is likely allowing water inside the column.

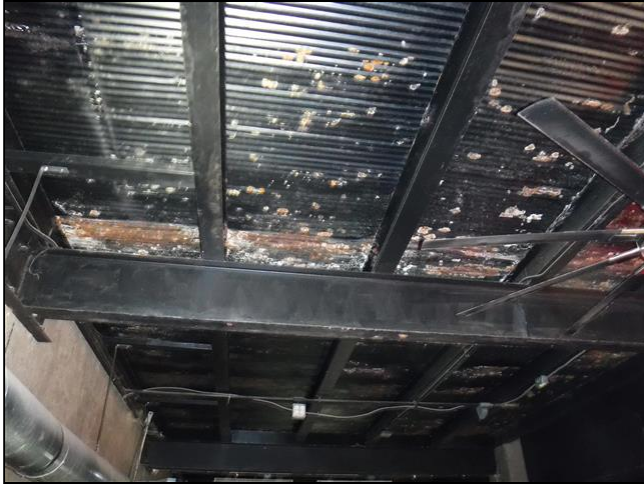
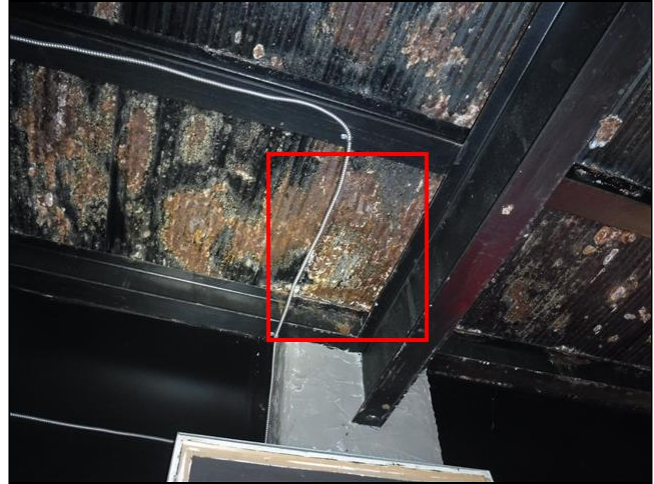
101 - The metal ceiling is rusted and shows advanced deterioration in areas from leaking water. Recommend evaluation and upgrade of the 2nd story residential patio by a licensed concrete contractor to deter further damage to the ceiling and surrounding components.

2.2 Item 1(Picture) 101 - Metal patio ceiling shows advanced deterioration and leaking.

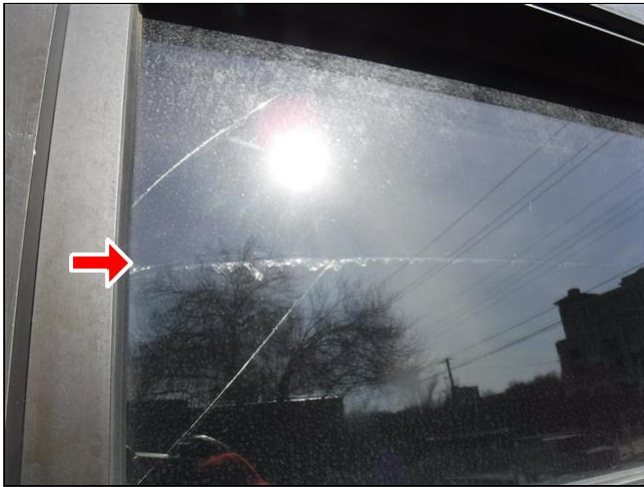
- 101 Enclosed patio glass above the door is cracked. Recommend a licensed window contractor to replace the cracked glass as desired.
- A majority of the exterior windows were not operable but could likely be serviced to maintain functionality. Recommend a licensed window contractor to evaluate and repair as needed.

2.3 Item 1(Picture) 101 - Crack in the overhead patio door glass

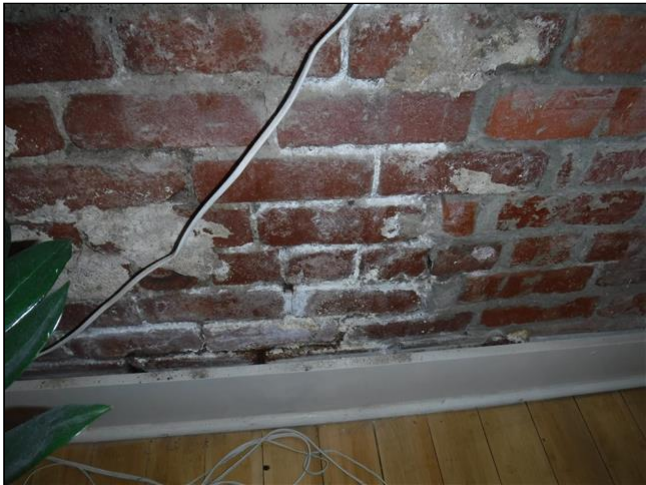
3.1 Walls (Structural)
(See 2.0.3) As with the deterioration of the exterior brick walls, there is also interior deterioration of the inside of those walls visible in the front part of the building in suites 105 and 101. Recommend upgrading exterior water diversion techniques to help prolong the lifespan of the interior brick walls. Repair the interior bricks as needed to deter further deterioration. (FYI....Loose bricks can fall and damage property or create a safety hazard.)

3.1 Item 1(Picture) 105 - White efflorescence indicating water intrusion.

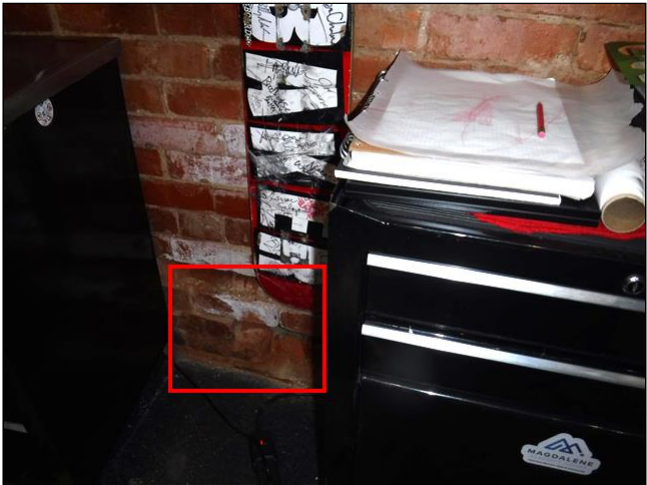
3.1 Item 2(Picture) 101 - Interior south brick wall shows advanced deterioration and efflorescence on the bottom half of bricks.

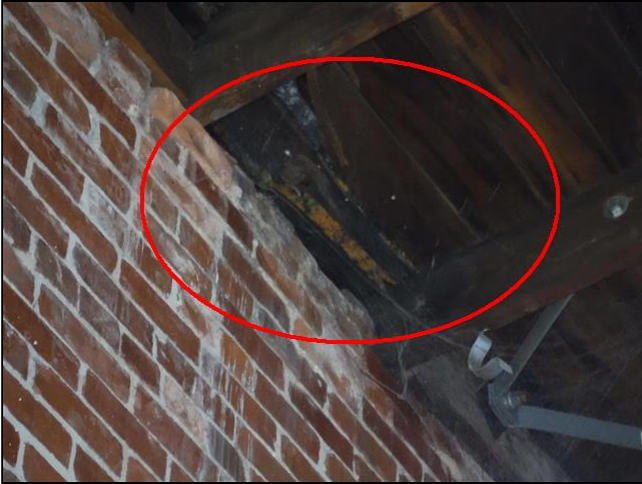
105 - The wood ceiling shows advanced deterioration above the entryway. Recommend a licensed contractor to evaluate and repair as needed to maintain the intended structural support. Further deterioration has likely been halted when the new roof was installed.

3.4 Item 1(Picture) Evidence of wood roof structure deterioration.

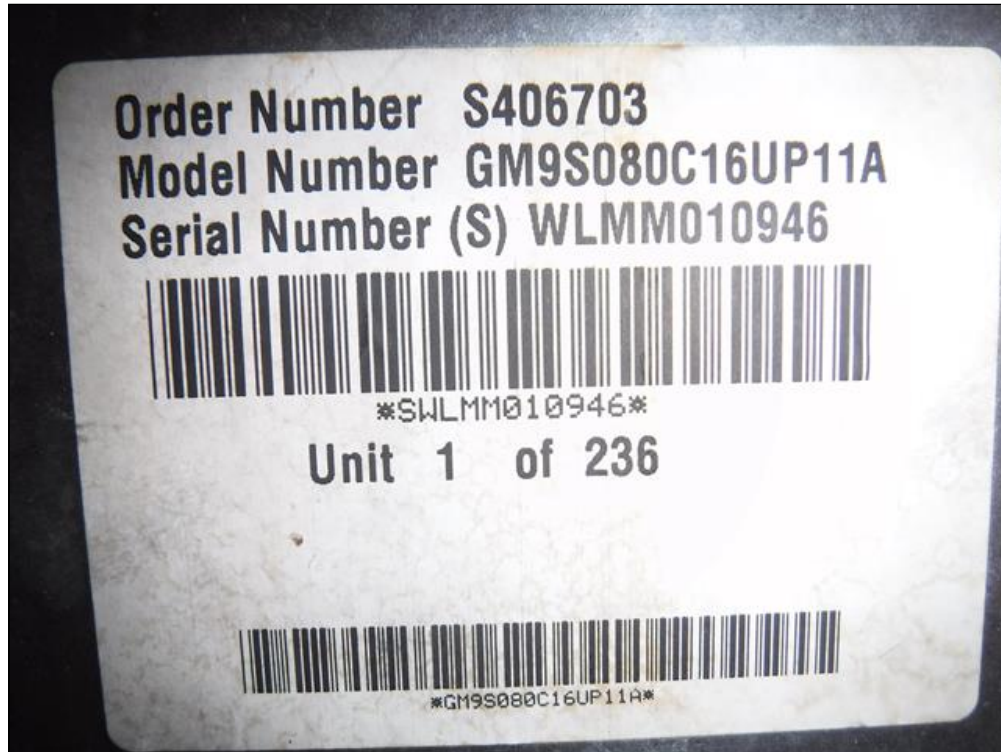
105 - 37 or 17yr old Interior HVAC Unit

- 4.0 Heating Equipment
- (1) 105 - Interior heating unit was not operational when onsite. The seller called an HVAC technician who diagnosed the problem fixed half and ordered some parts for the other issue.

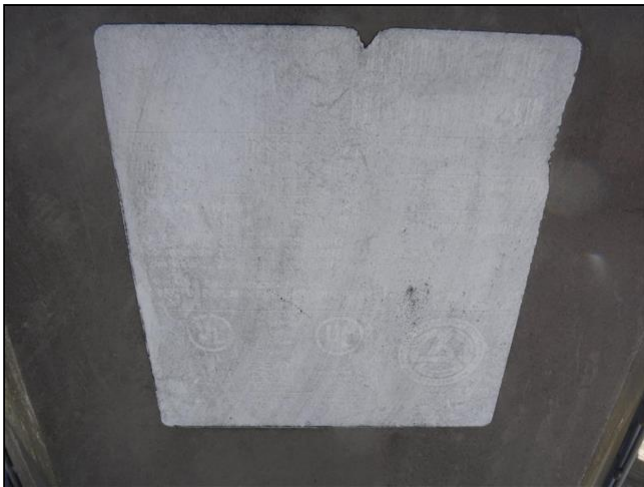
- The rooftop HVAC units (A/C and Heat Pumps) were not identifiable for each unit and the data plates could not be read. Recommend yearly preventative maintenance be completed on all the HVAC system, which can then be identified and labeled for future service.
- The air conditioner function was not tested for proper operation due to the outside air temperature being 60 degrees or less. HVAC manufacturers state that the units should not be activated if the temperature has been less than 60 degrees for 1 hour prior to potential activation. Prolonged activation may void warranties and/or ruin the compressor. Additionally, a proper temperature differential cannot be verified due to the inadequate exterior temperature differential needed for the A/C to function efficiently. If you are concerned with the system in question, please contact a licensed HVAC contractor for a full evaluation.

4.6 Item 1(Picture) Rooftop HVAC components were not identifiable and the labels could not be read.

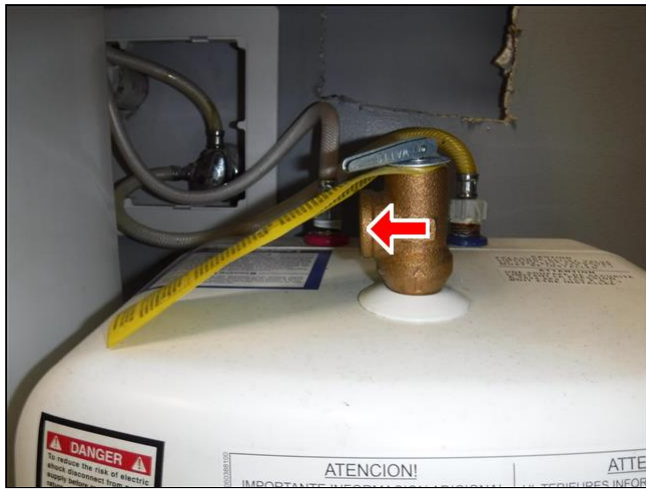
(2) Shared Hallway Single Bathroom - Water heater TPRV does not extend to a drain or the exterior. This is a potential safety hazard for those in proximity if the valve is activated. Recommend a licensed plumber to evaluate and upgrade as desired.

5.2 Item 1(Picture) TPRV does not have an approved extension.

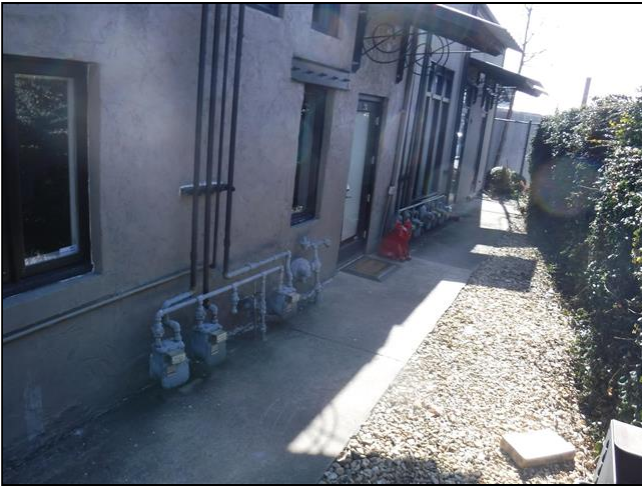
- Only shutoffs that could be located are on the rear of the building at the gas meter. Meters are not identifiable.

5.5 Item 1(Picture) Unidentifiable Gas Meters on the Rear of the property.

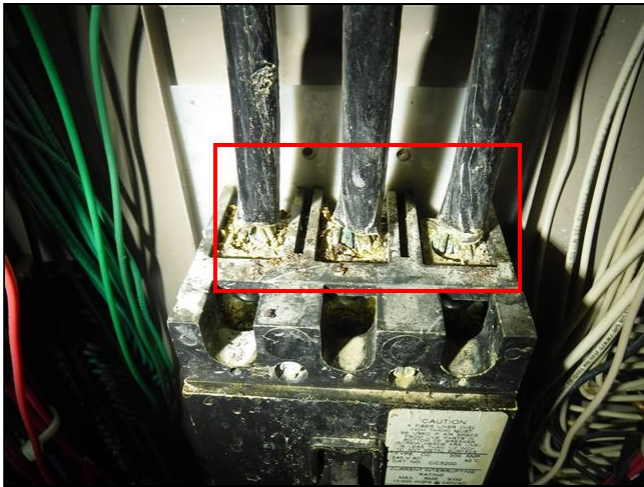
Entrance conductors in the electric panels of Ste 105 show prior moisture contact and corrosion. It is believed that water had leaked inside the conduit from the roof. After the new roof was installed, the leaking appears to have stopped. Recommend a licensed contractor to evaluate and repair the wire/connections as needed.

6.0 Item 1(Picture) 101 - Wire corrosion on the electrical entrance conductors.

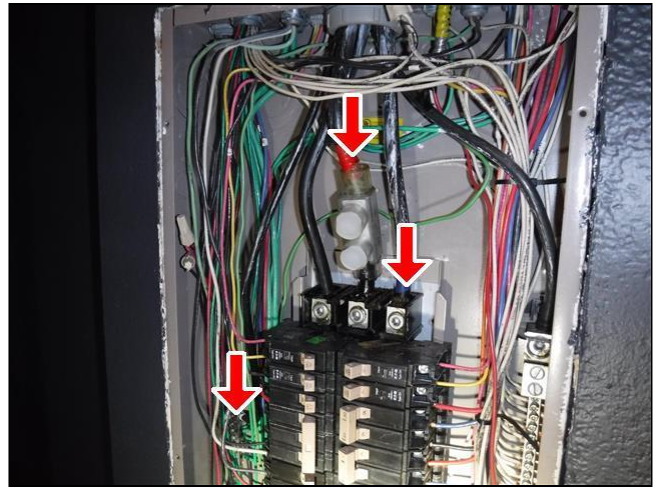
6.0 Item 2(Picture) 105 - Wire corrosion on the electrical entrance conductors.

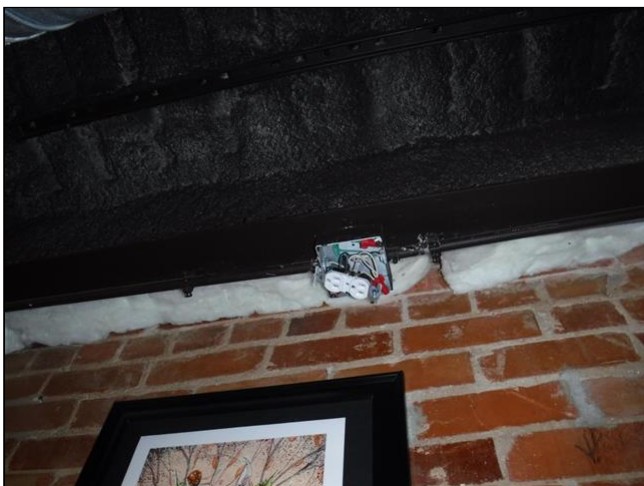
All Units - Receptacles not secured or don't have a cover. Recommend securing the splice boxes and installation of covers on the receptacles to deter premature deterioration and to deter potential safety hazards.

6.3 Item 1(Picture) 101 - Loose electrical receptacle

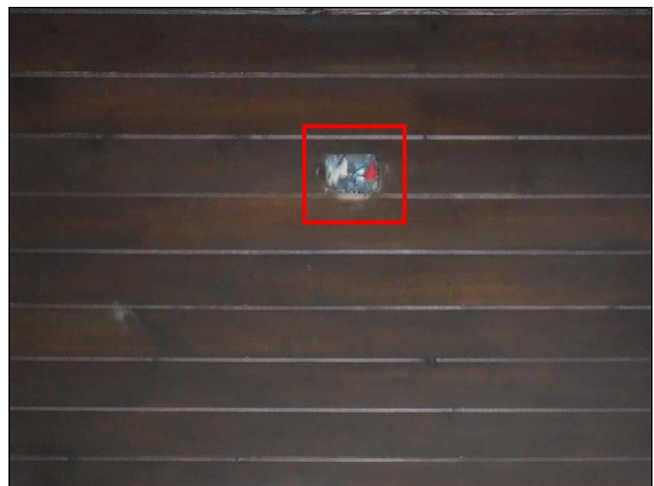
6.3 Item 2(Picture) 103 - Missing electrical box cover.

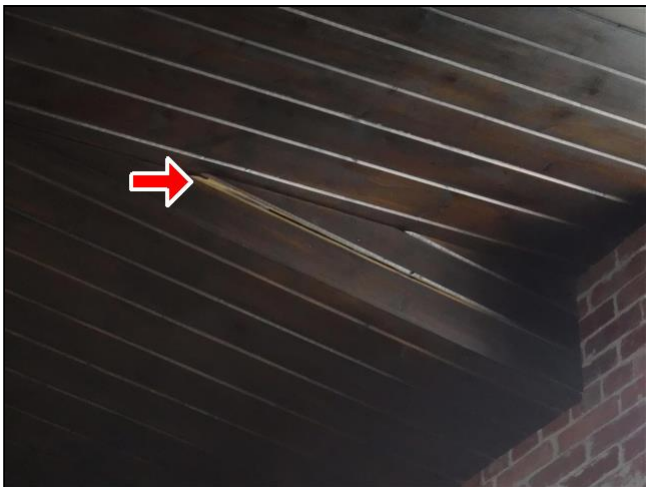
Ste 103 - Wood ceiling panel is loose. Recommend a licensed contractor to secure/repair it to deter further deterioration.

7.0 Item 1(Picture) 103 - Wood ceiling panel in the entry is loose.

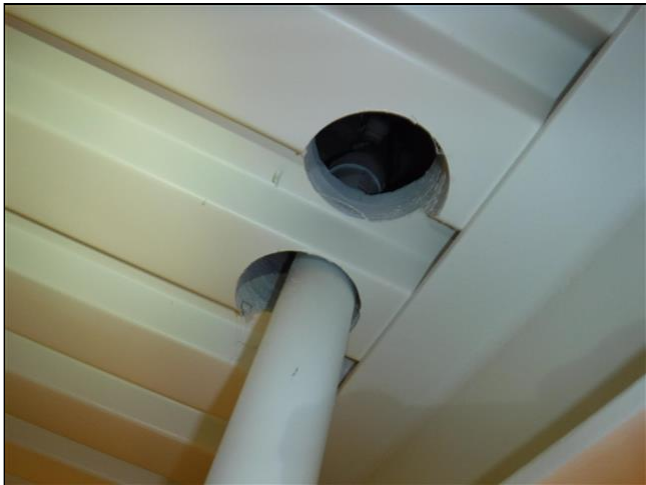
105/103 - The firewall separation between floors is missing in visible locations. This does not afford the intended protection against a fire in an adjacent unit. I recommend a qualified contractor to evaluate/upgrade all floor penetrations (both hidden and exposed) for the required fire protection.

1.4 Item 1(Picture) 105 - Unsecured openings to the upstairs residential units.

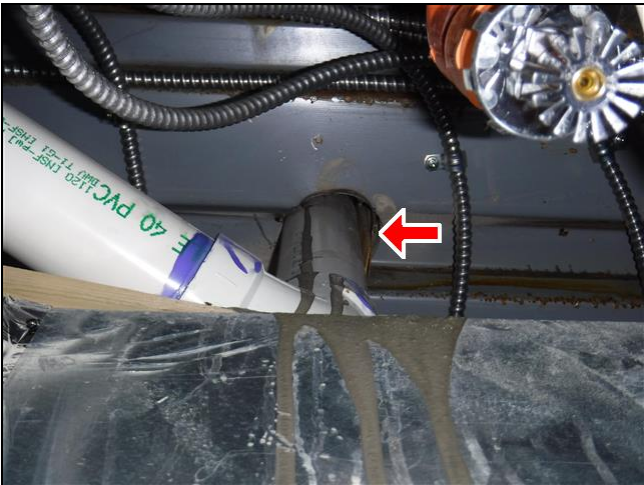
1.4 Item 2(Picture) 103 - Unsecured openings to the upstairs residential units.

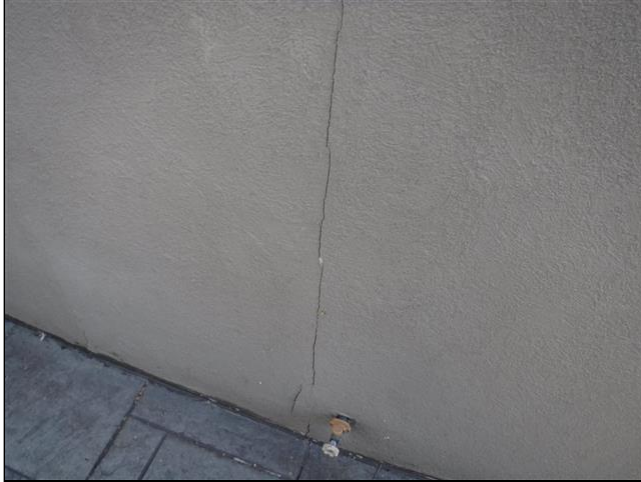
(2) The EIFS siding at the rear of building is beginning to deteriorate at the seams causing cracks and is damaged from the gate lock on the corner of the building. Further deterioration can occur if not addressed. Recommend a licensed EIFS/Stucco contractor to evaluate and repair as needed.

2.0 Item 1(Picture) 101 - Rear building EIFS is cracking at the seams.

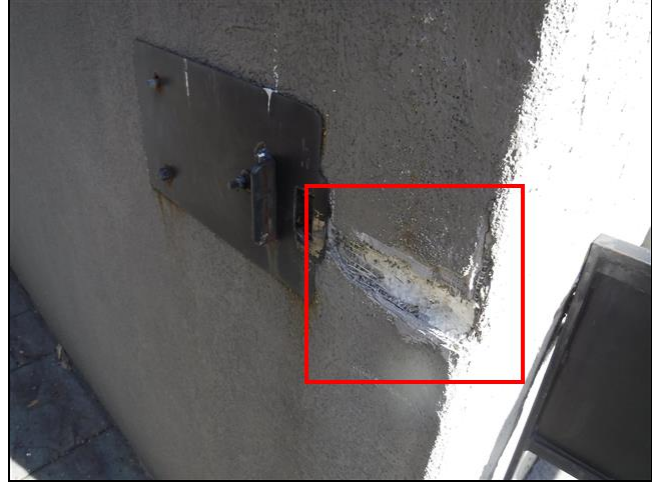
2.0 Item 2(Picture) 101- Exterior rear wall has been damaged by the gate lock.

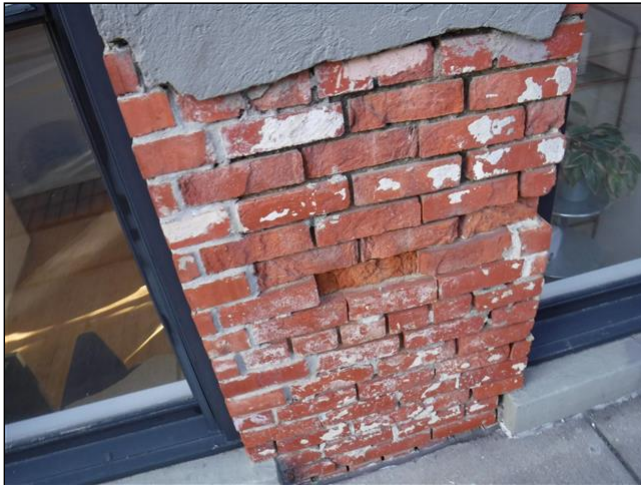
(3) The brick/concrete siding at the exterior shows advanced deterioration and is missing mortar in areas. Further deterioration can occur if not addressed. Recommend a licensed masonry contractor to evaluate and repair/replace as needed.

2.0 Item 3(Picture) Aged/Deteriorated bricks on the exterior of the building.

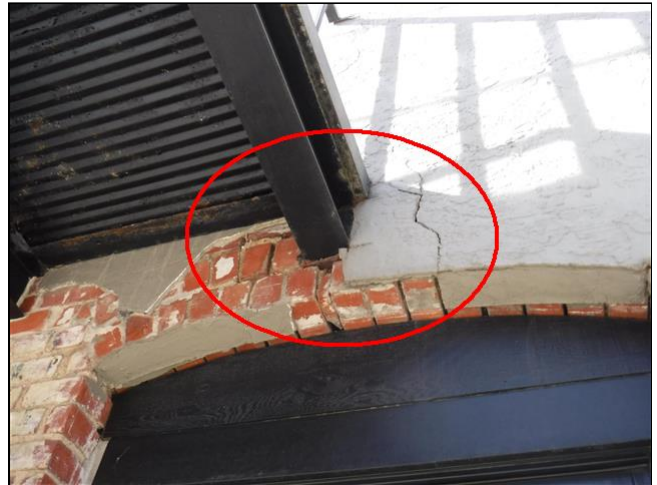
2.0 Item 4(Picture) Brick and concrete screed deterioration at the 2nd story patio on the front of the building.

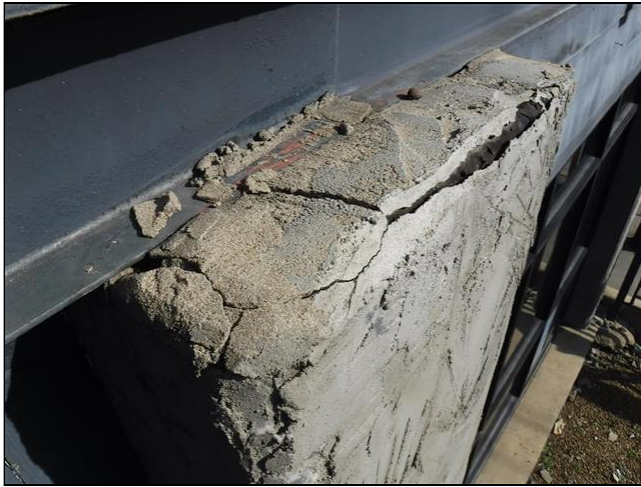
2.0 Item 5(Picture) 101 - Top concrete screeded pillars show advanced deterioration and is likely allowing water inside the column.

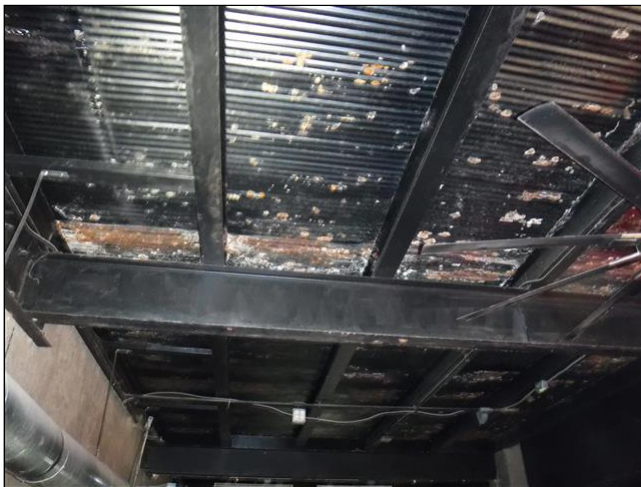
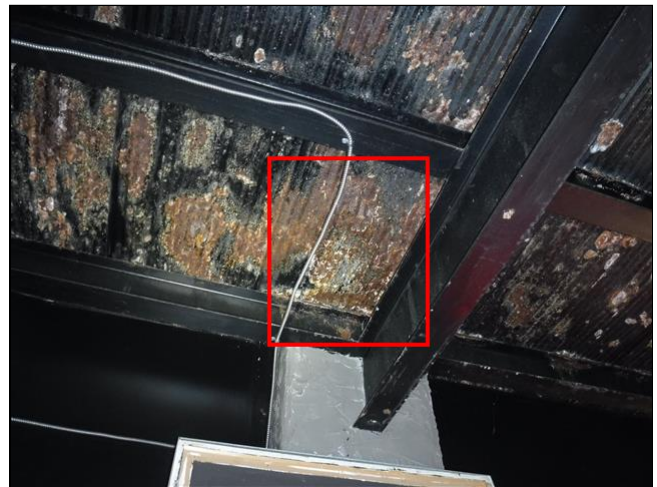
101 - The metal ceiling is rusted and shows advanced deterioration in areas from leaking water. Recommend evaluation and upgrade of the 2nd story residential patio by a licensed concrete contractor to deter further damage to the ceiling and surrounding components.

2.2 Item 1(Picture) 101 - Metal patio ceiling shows advanced deterioration and leaking.

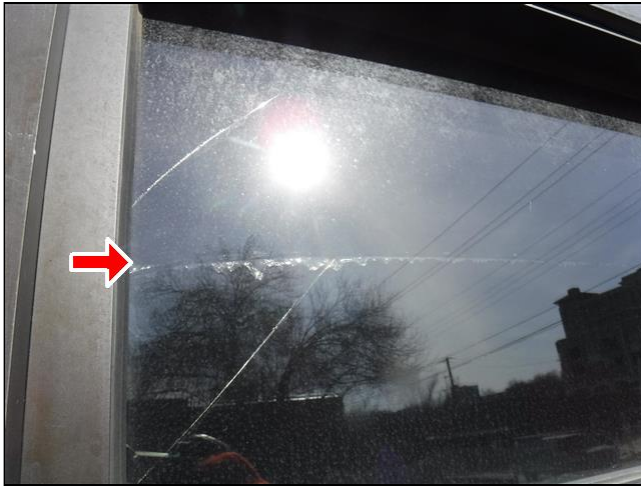
- 101 Enclosed patio glass above the door is cracked. Recommend a licensed window contractor to replace the cracked glass as desired.
- A majority of the exterior windows were not operable but could likely be serviced to maintain functionality. Recommend a licensed window contractor to evaluate and repair as needed.

2.3 Item 1(Picture) 101 - Crack in the overhead patio door glass

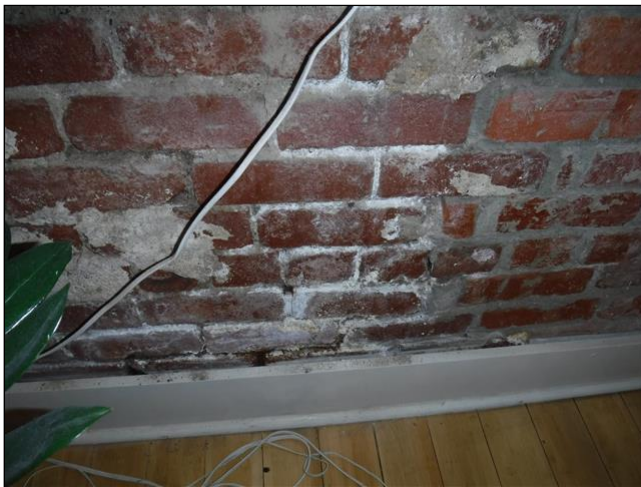
(See 2.0.3) As with the deterioration of the exterior brick walls, there is also interior deterioration of the inside of those walls visible in the front part of the building in suites 105 and 101. Recommend upgrading exterior water diversion techniques to help prolong the lifespan of the interior brick walls. Repair the interior bricks as needed to deter further deterioration. (FYI....Loose bricks can fall and damage property or create a safety hazard.)

3.1 Item 1(Picture) 105 - White efflorescence indicating water intrusion.

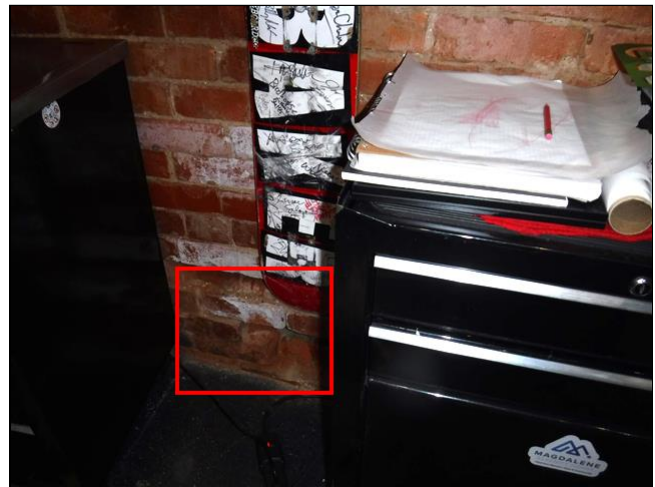
3.1 Item 2(Picture) 101 - Interior south brick wall shows advanced deterioration and efflorescence on the bottom half of bricks.

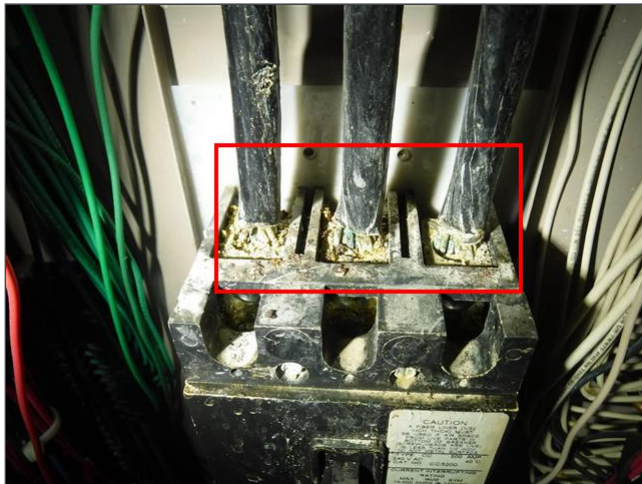
Entrance conductors in the electric panels of Ste 105 show prior moisture contact and corrosion. It is believed that water had leaked inside the conduit from the roof. After the new roof was installed, the leaking appears to have stopped. Recommend a licensed contractor to evaluate and repair the wire/connections as needed.

6.0 Item 1(Picture) 101 - Wire corrosion on the electrical entrance conductors.

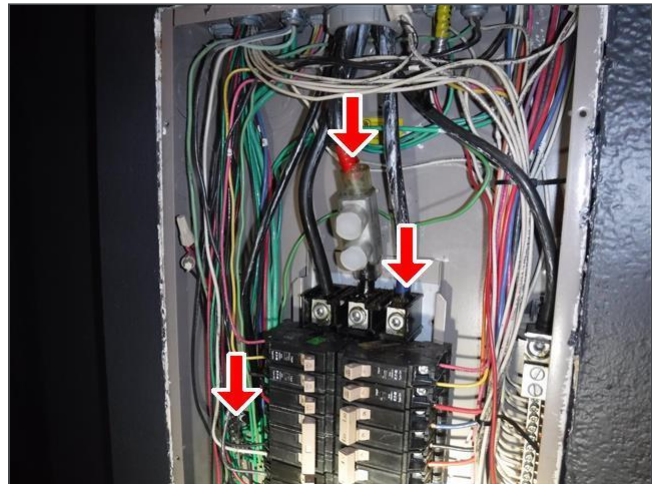
6.0 Item 2(Picture) 105 - Wire corrosion on the electrical entrance conductors.

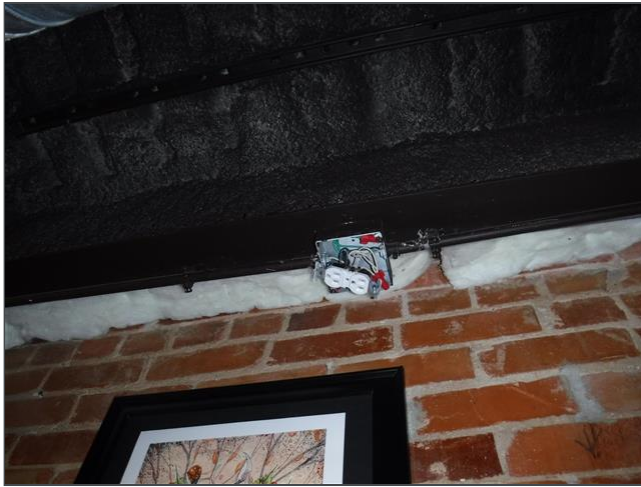
All Units - Receptacles not secured or don't have a cover. Recommend securing the splice boxes and installation of covers on the receptacles to deter premature deterioration and to deter potential safety hazards.

6.3 Item 1(Picture) 101 - Loose electrical receptacle

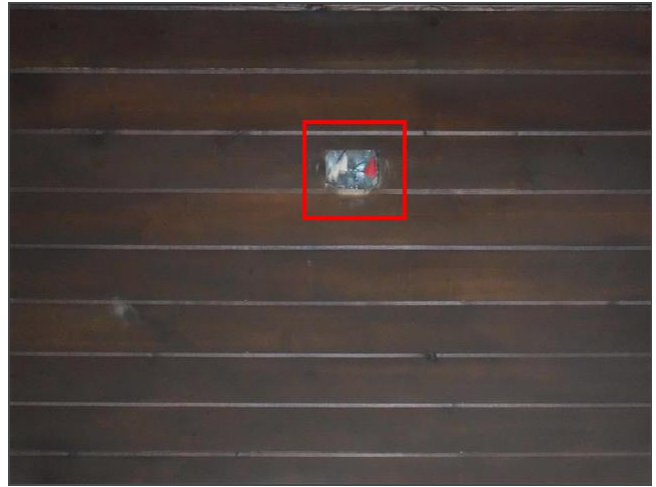
6.3 Item 2(Picture) 103 - Missing electrical box cover.

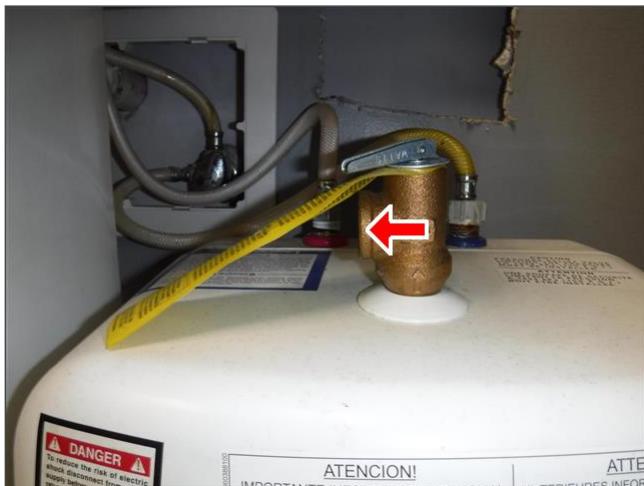
- (1) 103 - Electric water heater was unplugged and could not be verified.
(2) Shared Hallway Single Bathroom - Water heater TPRV does not extend to a drain or the exterior. This is a potential safety hazard for those in proximity if the valve is activated. Recommend a licensed plumber to evaluate and upgrade as desired.

5.2 Item 1(Picture) TPRV does not have an approved extension.
