# Inspection Report

**Property Address:**  
1234 Graceland Dr  
Graceland AR 123456

**A Superior Inspection LLC**

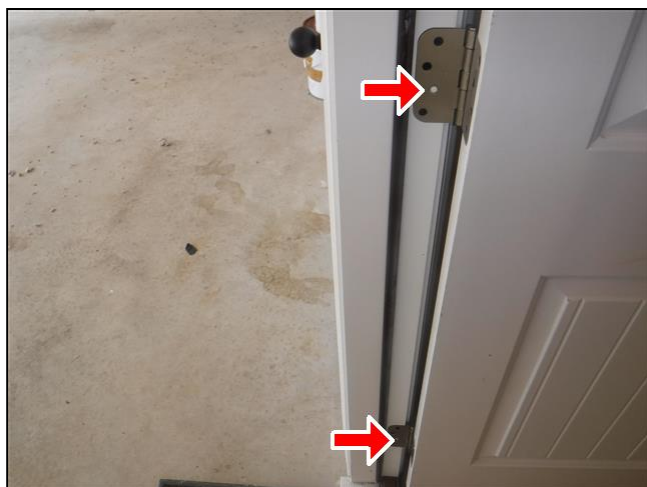
2.4 Item 1(Picture) Garage door hinges are missing mounting hardware.

- 2.0 Driveway  
Inspected
- 2.1 Landscaping (in relation to the home)  
Inspected
- 2.2 Wall Cladding, Flashing & Trim  
Inspected  
Caulking recommended around the exterior of the home. Locations include but are not limited to: windows, the garage door, utility penetrations and most material intersections. To maintain a weather barrier and for energy efficiency, recommend reapplication/installation of caulking.
- 2.3 Eaves, Soffits & Fascias  
Inspected
- 2.4 Entry Doors  
Inspected
  - Missing mounting hardware on garage occupant door hinge. Door hinges are designed to be installed with all mounting hardware to provide its intended support and to prevent the weight of the door from cracking the door jamb. Recommend installing all door hinge mounting hardware to deter premature deterioration.

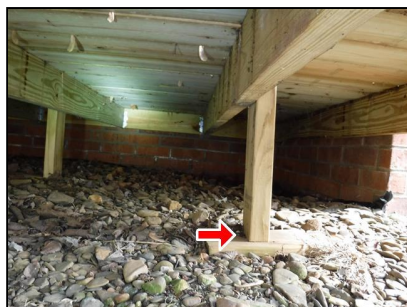
2.6 Item 1(Picture) Deck footings non-standard

- The deck footings/support posts are non-standard. Recommend a licensed contractor to upgrade as needed.
- Ledger board is lacking mounted hardware OR is non-standard. Standard construction practices recommend the ledger to be greater than or equal of the deck joist and have 5/8 galvanized "Lag Screws" or "Carriage Bolts" (preferred), approximately every 36 inches. Additionally, the deck joists are to be mounted to the ledger/band joist with joist hangers or wood blocking. Recommend a licensed deck contractor to upgrade as needed.

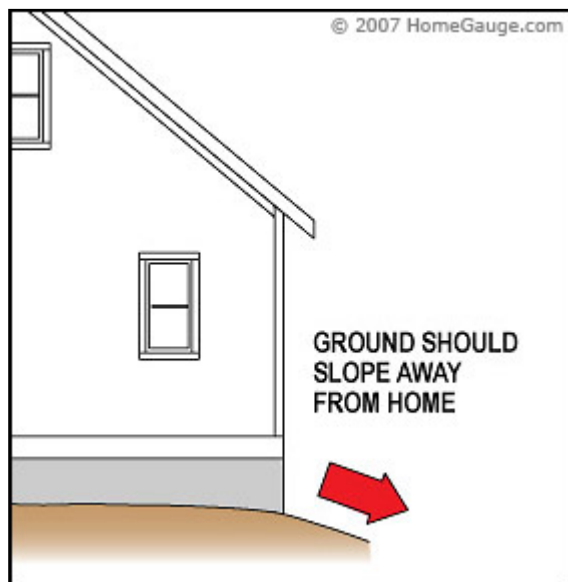
2.9 Item 1(Picture) Drainage Diagram

It is recommended to maintain a positive grade from the siding to the yard to promote water drainage away from the home. If rain water is allowed to drain near the foundation, over time, the earth around the foundation may compress and/or move possibly causing settlement.

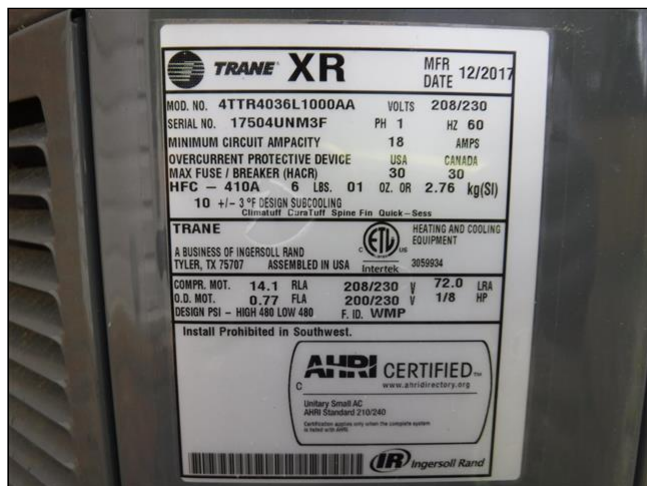
~2yr old Exterior A/C Unit

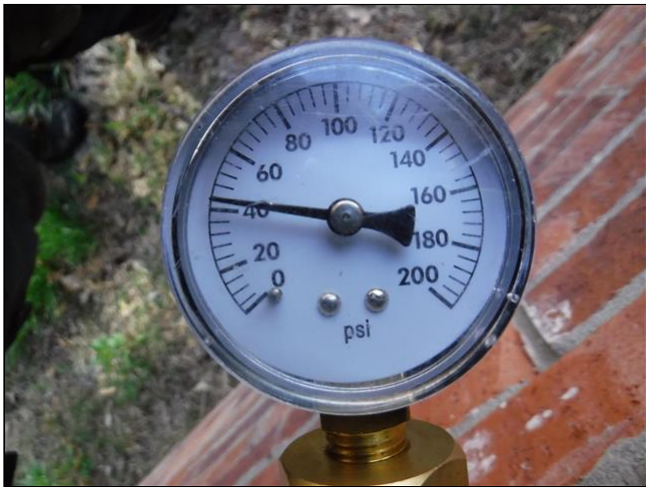
~42psi Water Pressure (60-80psi recommended)

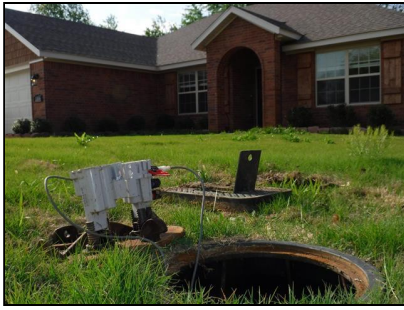
- Exterior water shut-off is located in the ground at the meter on the NW corner of the property.
- Interior water shut-off and pressure manifold is beside the water heater.
- Main waste clean-out is on the east side of the home.

7.0 Item 1(Picture) NW corner of the property water meter location

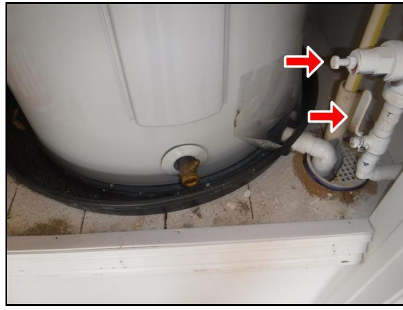
7.0 Item 2(Picture) Interior water shutoff and pressure manifold

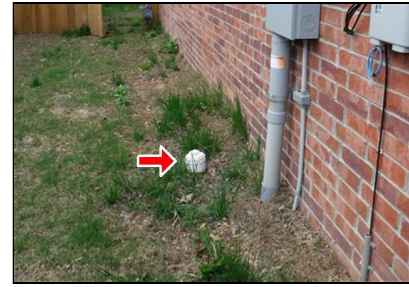
7.0 Item 3(Picture) Main waste clean-out location.

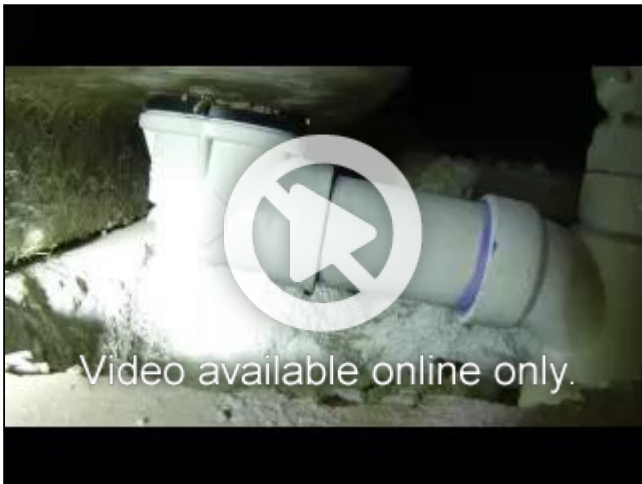
7.1 Item 1(Video) Water leaking out of the drain gasket for the master bath whirlpool tub.

- Master bath whirlpool tub drain leaked water into the cabinets after filling the tub and draining. Recommend a licensed plumber to evaluate and repair to deter moisture damage to the surrounding components.

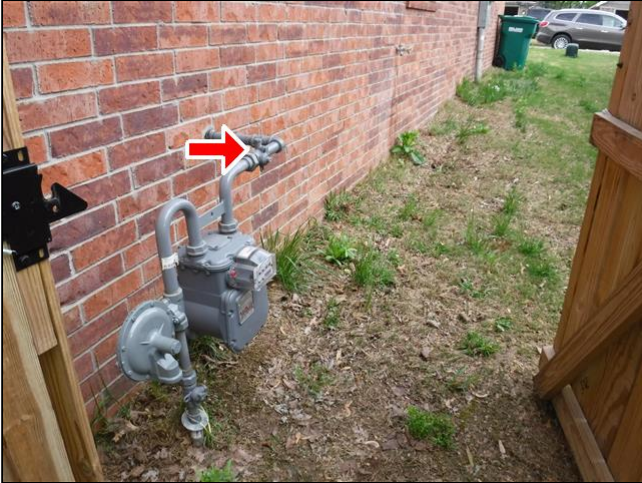
- The main fuel shut-off is at the gas meter on the east side of the home.

7.4 Item 1(Picture) Exterior gas meter and shutoff location.

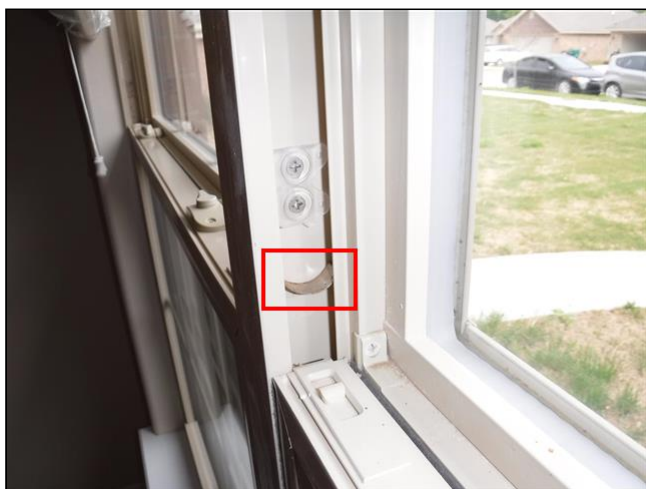
8.4 Item 1(Picture) NE bedroom window spring is disconnected

- The right window in the NE guest bedroom is difficult to operate due to a spring that has come off its mount. Recommend repair by a licensed window professional.

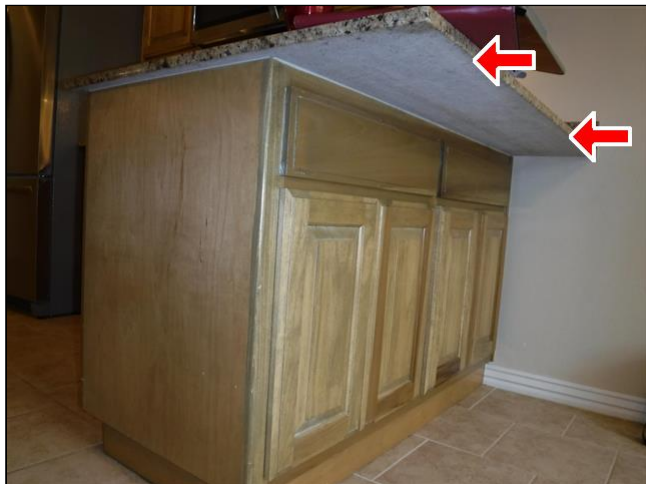
8.6 Item 1(Picture) Missing counter top supports.

(2) Countertop over hangs' more than a couple of inches and greater than 3ft wide are recommended to have additional supports, which is based on material/thickness. Typically - 3/4in rock countertops are recommend to have additional supports for over 6in overhangs. 1 1/4in are recommended to have additional supports for over 10in overhangs. Recommend adding additional supports per industry standards.

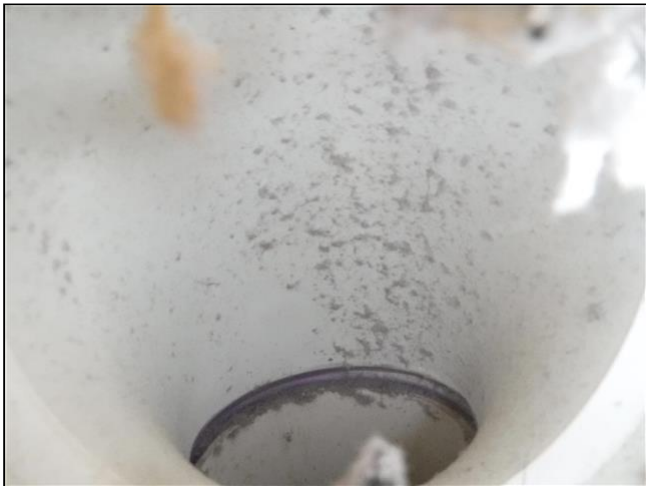
9.1 Item 1(Picture) No lint visible in the dryer vent.

Recommend establishing a cleaning frequency of the dryer vent. Dryer lint buildup may increase drying times/utility bills, decrease dryer life span and even result in fire. Cleaning frequency depends on number of house hold occupants and dryer usage, but industry standard is once a year.

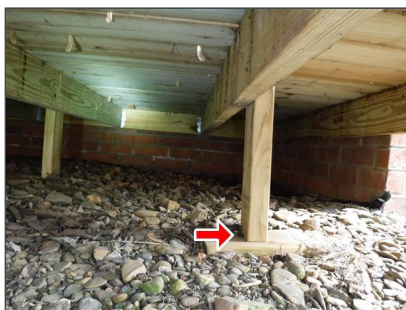
2.6 Item 1(Picture) Deck footings non-standard

- The deck footings/support posts are non-standard. Recommend a licensed contractor to upgrade as needed.
- Ledger board is lacking mounted hardware OR is non-standard. Standard construction practices recommend the ledger to be greater than or equal of the deck joist and have 5/8 galvanized "Lag Screws" or "Carriage Bolts" (preferred), approximately every 36 inches. Additionally, the deck joists are to be mounted to the ledger/band joist with joist hangers or wood blocking. Recommend a licensed deck contractor to upgrade as needed.

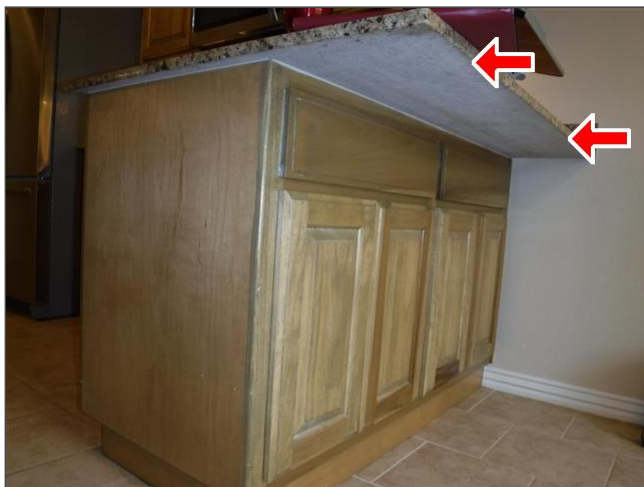
8.6 Item 1(Picture) Missing counter top supports.

(2) Countertop over hangs' more than a couple of inches and greater than 3ft wide are recommended to have additional supports, which is based on material/thickness. Typically - 3/4in rock countertops are recommend to have additional supports for over 6in overhangs. 1 1/4in are recommended to have additional supports for over 10in overhangs. Recommend adding additional supports per industry standards.

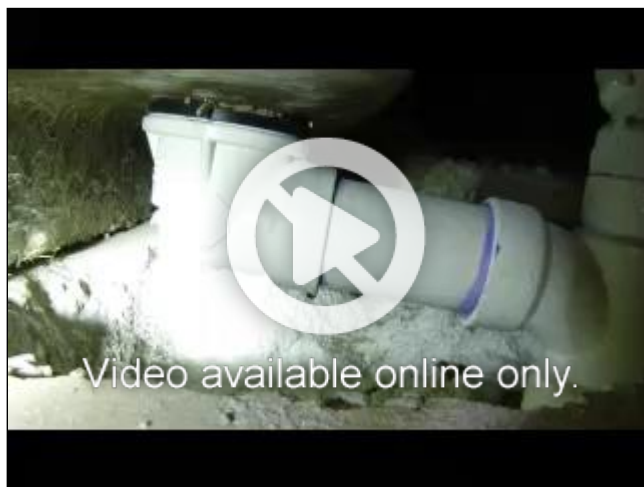
7.1 Item 1(Video) Water leaking out of the drain gasket for the master bath whirlpool tub.

- Master bath whirlpool tub drain leaked water into the cabinets after filling the tub and draining. Recommend a licensed plumber to evaluate and repair to deter moisture damage to the surrounding components.

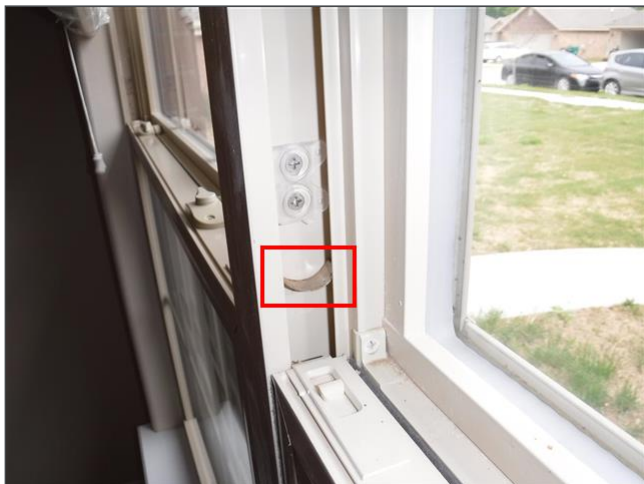
8.4 Item 1(Picture) NE bedroom window spring is disconnected

- The right window in the NE guest bedroom is difficult to operate due to a spring that has come off its mount. Recommend repair by a licensed window professional.
